# Manhole Inspection Summary

Manhole # S57G\_\_006MH

Insp Date: **7/1/08 10:10 AM**

**Location** Address: **210 s grundy st**

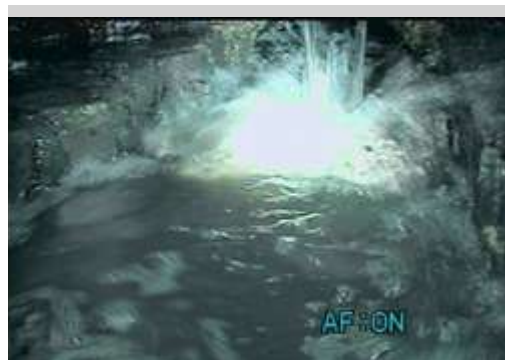
bench debris

channel debris

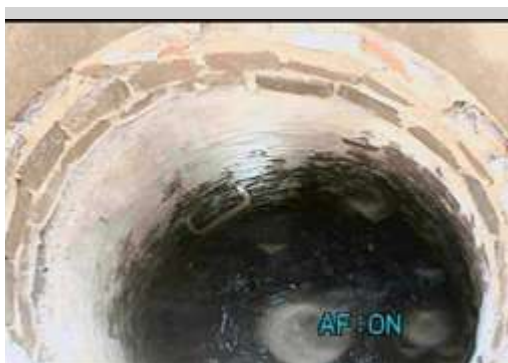
Defect 2

Count: **3** Missing: **2** ☒ **Corroded**

steps

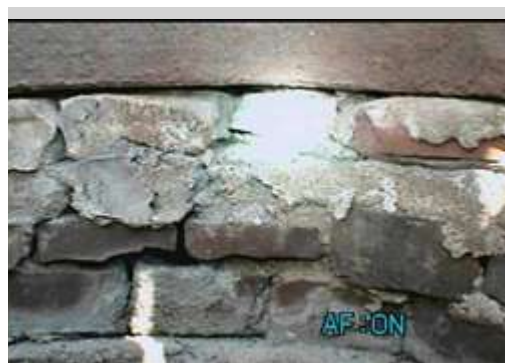
Defect 1

Condition: ☐ Sound ☐ Cracked ☐ Root Intrusion ☒ **Loose Brick** ☒ **Deteriorated**

chimney loose bricks,deteriorated,  
frame adj

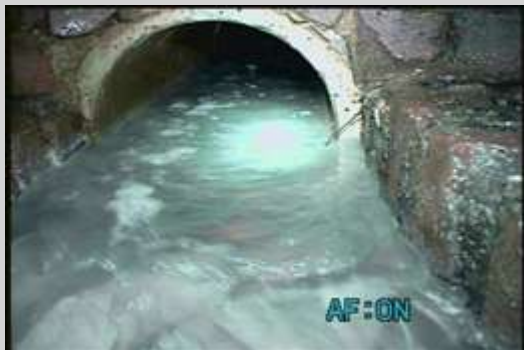
12 O'Clock Outflow

10 in. Circular Gravity Sewer  
Pipe Out @ 12 OClock

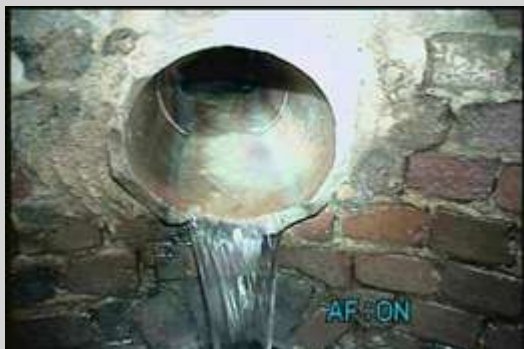
3 O'Clock Inflow

8 in. Circular Gravity Sewer  
Pipe In @ 3 OClock

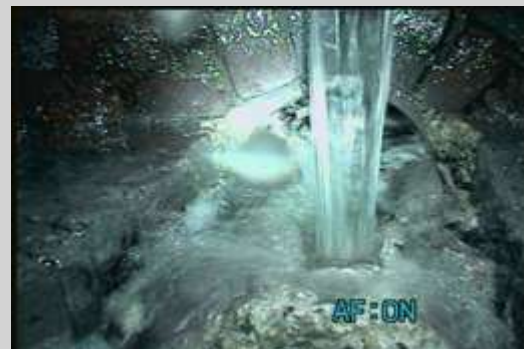
Drop In @ 3 OClock

couldnt get better pic due to water from drop above

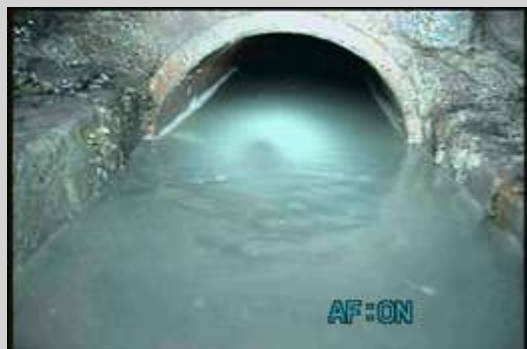
6 O'Clock Inflow

8 in. Circular Gravity Sewer  
Pipe In @ 6 O'Clock
